BULGARIAN FIGHTER COLOURS 1919–1948

Vol. 1

Rainbow No 9136

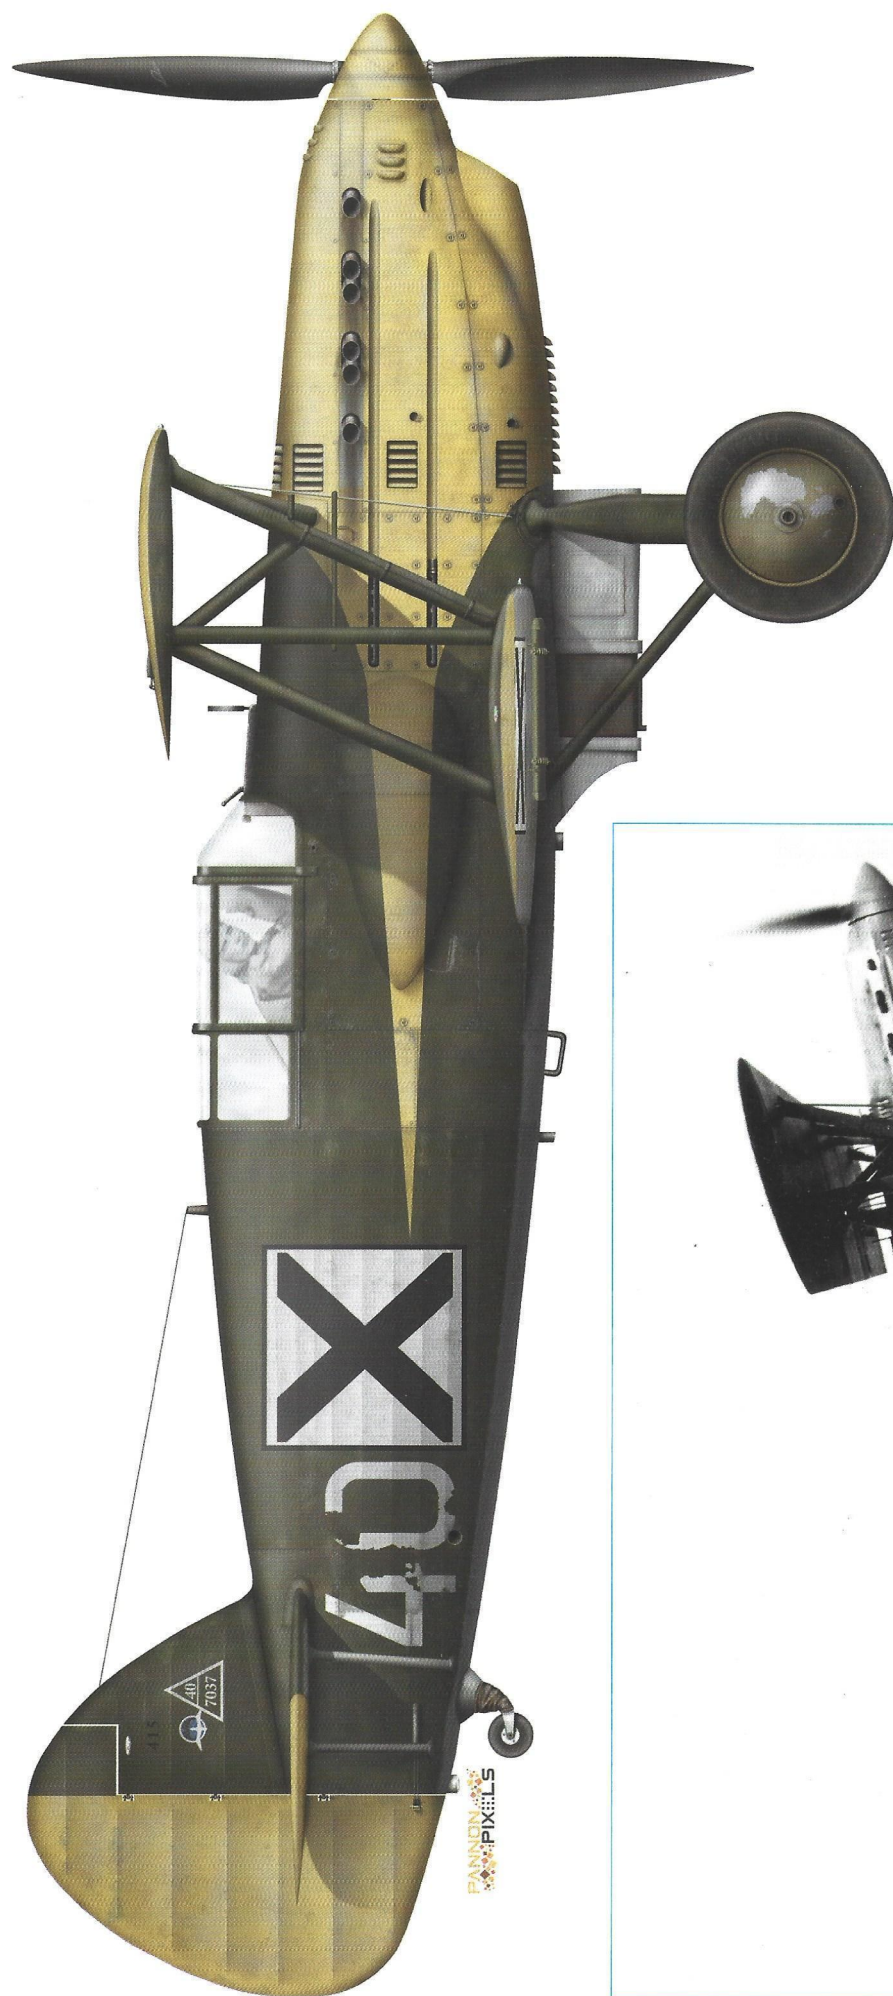
Avia B.534-V Dogaň, 40/7037 (c/n 415), Shkola za Višň Pilotáž, Marno Pole/Karlovo, mid-1941. Camouflage colours: unidentified Bulgarian mid-green on upper surfaces, on fuselage sides and wing surfaces, except for the fin, which stayed in original Czechoslovak khaki colour, over light grey on under surfaces. St. Andrew cross type VNV marking, in six positions. Yellow spinner, engine cowling, continued in a rearward tapering flash along the fuselage, upper and lower wingtips, rudder and elevators. White serial number on rear fuselage.

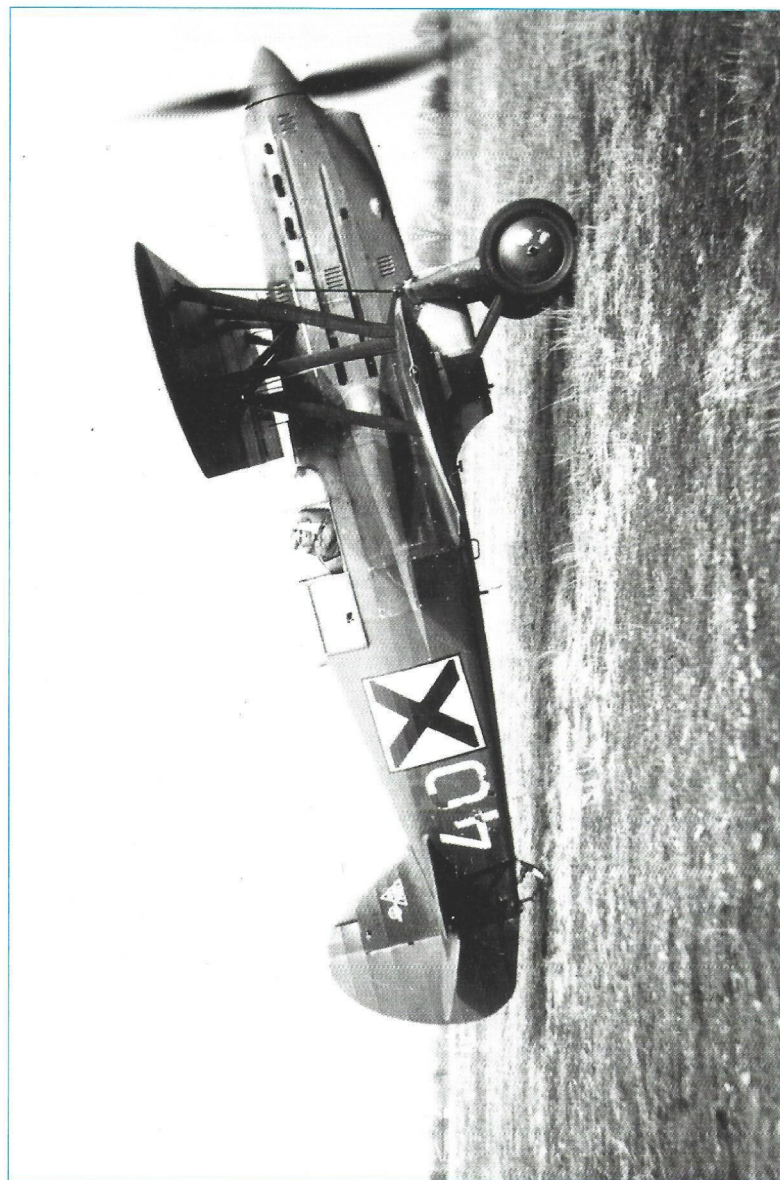
The Dogaň pilot signals with his right arm prior to takeoff. The following text is written on the original photo's verso: "With the Dogaň (Avia 534) in the Fighter school, Karlovo, 1941". Aircraft No. 40/7037, built in 1938, was one of the very few that displayed the original construction number on the starboard side fin, right above the factory emblem: 415. It was not written on the port side fin (or it was overpainted at a later stage), as per the photos featured on page 178.

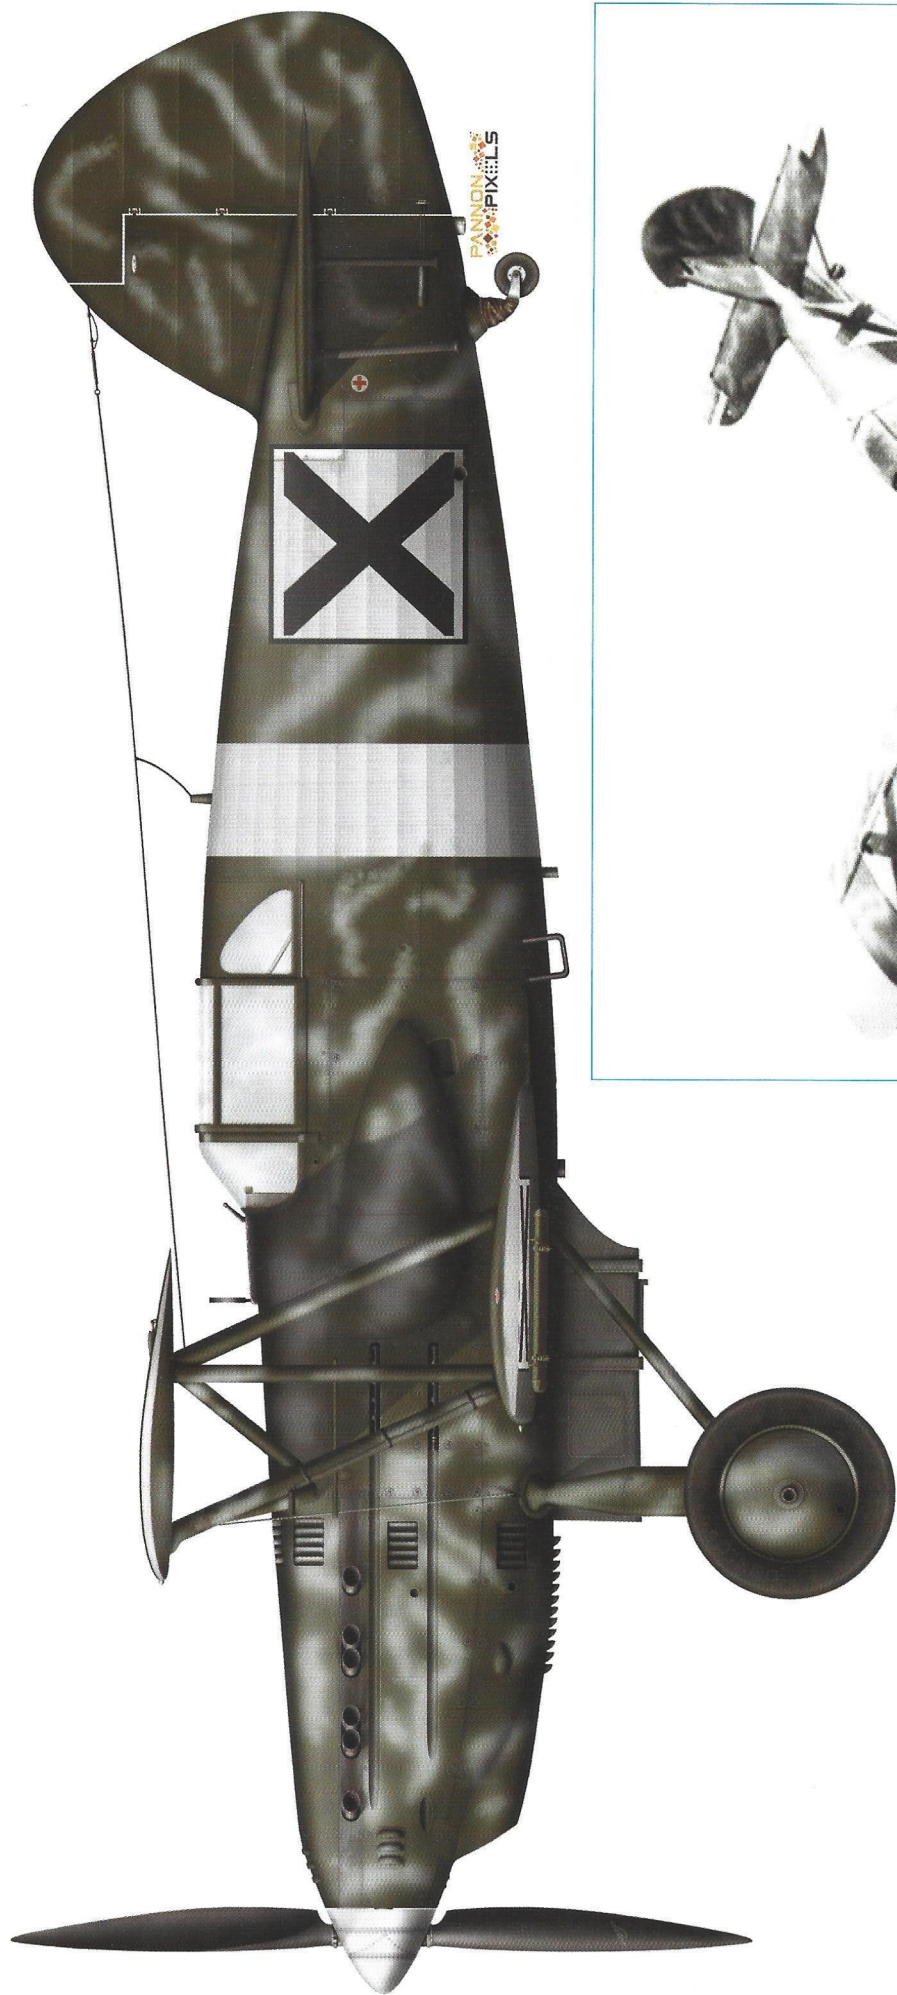
Avia B.534-IV Dogan, unidentified NN, 2/2. Shturmovi Orlyak, Plovdiv, early 1945. Camouflage colours: unidentified Bulgarian mid-green, covered with light grey squiggles on upper surfaces. Same light grey on under surfaces. Engine cowling painted dark green wraparound, also covered with grey squiggles. St. Andrew cross type marking on fuselage sides and wing surfaces, in six positions. White spinner, upper and lower wingtips, mid-fuselage ring.

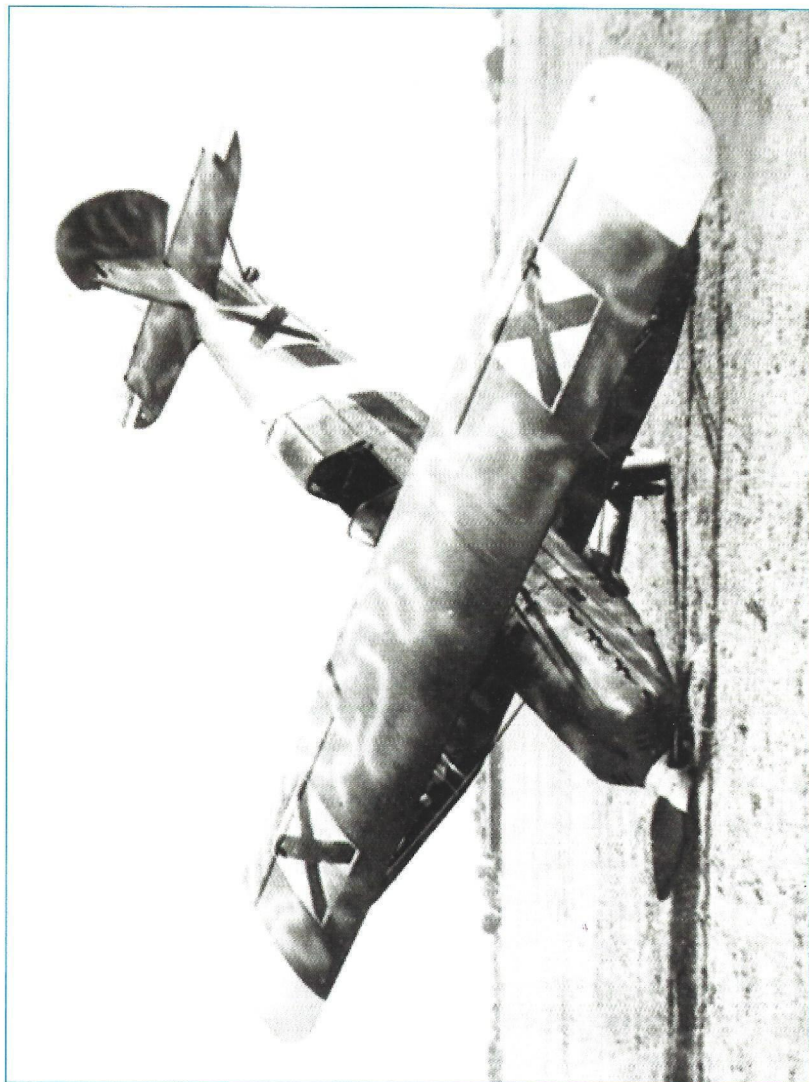
From 19 September 1944 on, the pro-Axis yellow identification colour gave way to the pro-Allied white, applied on both wingtips, as well as fuselage band. The spinner was painted white as well. The national marking remained unchanged, but the large size white serial number disappeared from the rear fuselage. A further change in the appearance of the pro-Allied Dogans happened sometimes in late October, when light grey irregular squiggles were sprayed over the original dark green camouflage colour. The wide, white mid-fuselage band and the marking pushed rearwards are unusual. The triangle is missing from the fin.

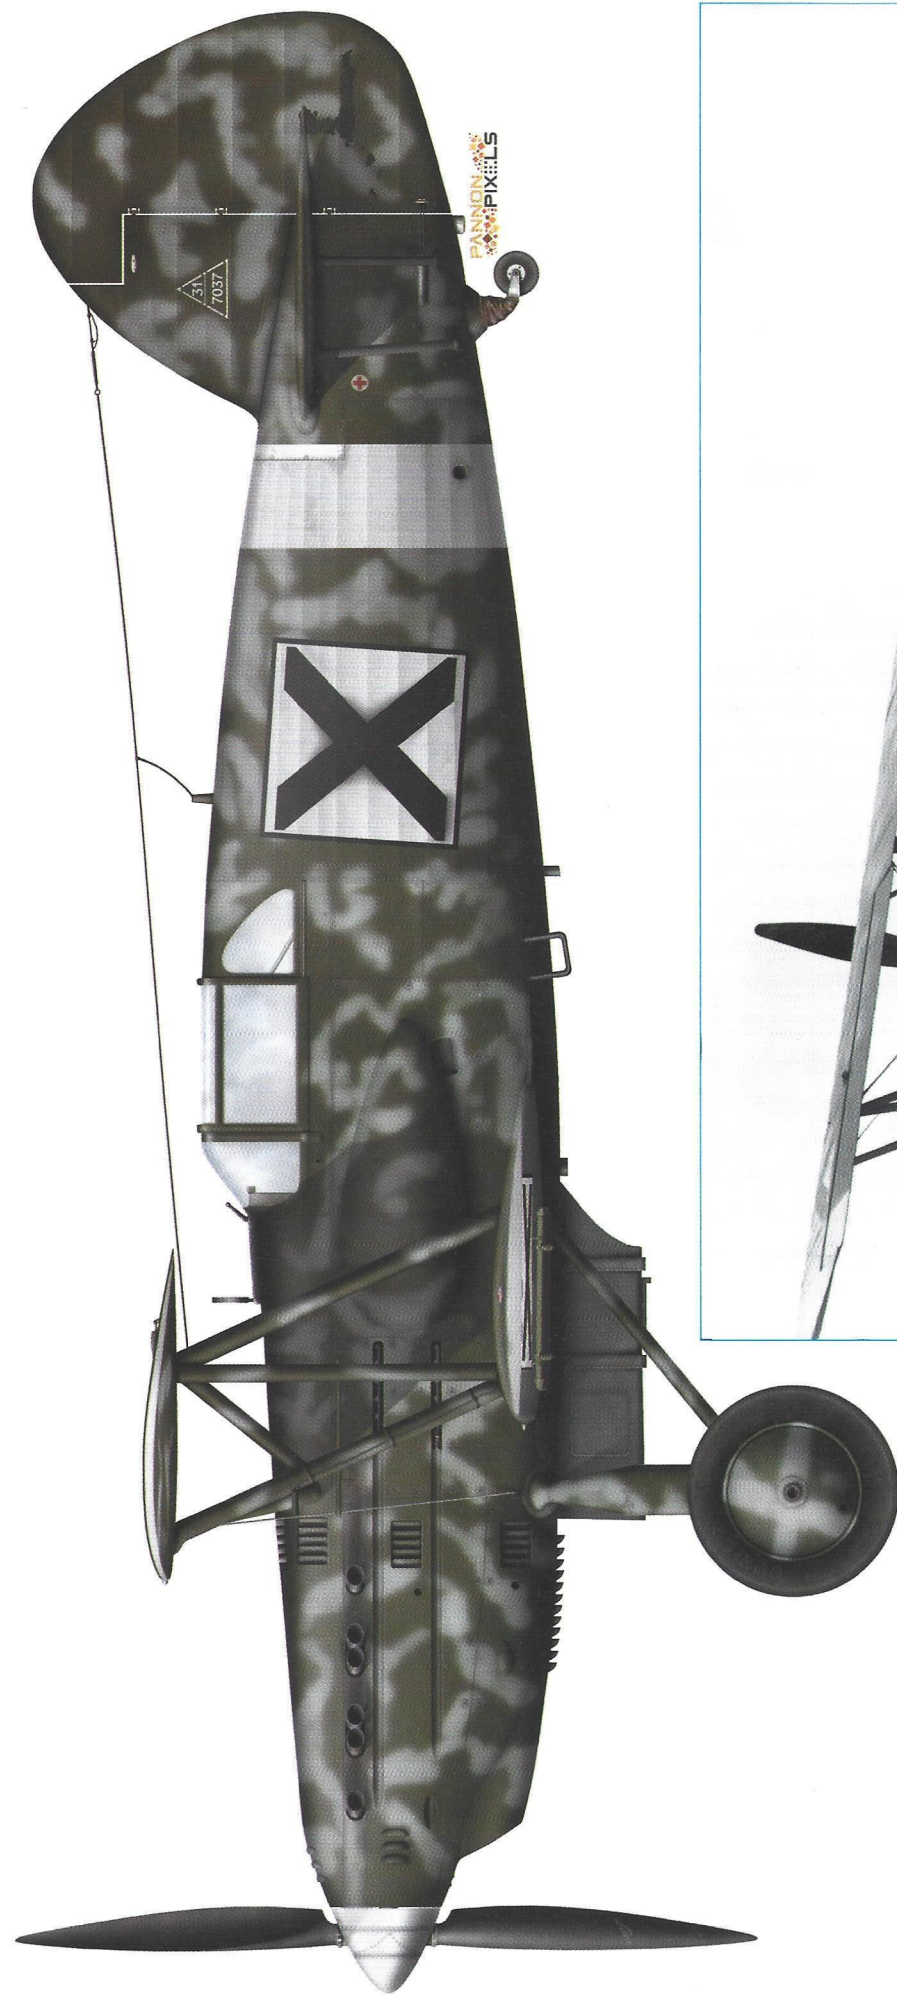
Avia B.534-IV Dogan, 31/7037, 2/2. Shturmovi Orlyak, Vrazhdebna, November 1944. Camouflage colours: unidentified Bulgarian mid-green, covered with light grey squiggles on upper surfaces. Same light grey on under surfaces. Engine cowling painted dark green wraparound, also covered with grey squiggles. St. Andrew cross type marking on fuselage sides and wing surfaces, in six positions. White spinner, upper and lower wingtips, rear fuselage ring.

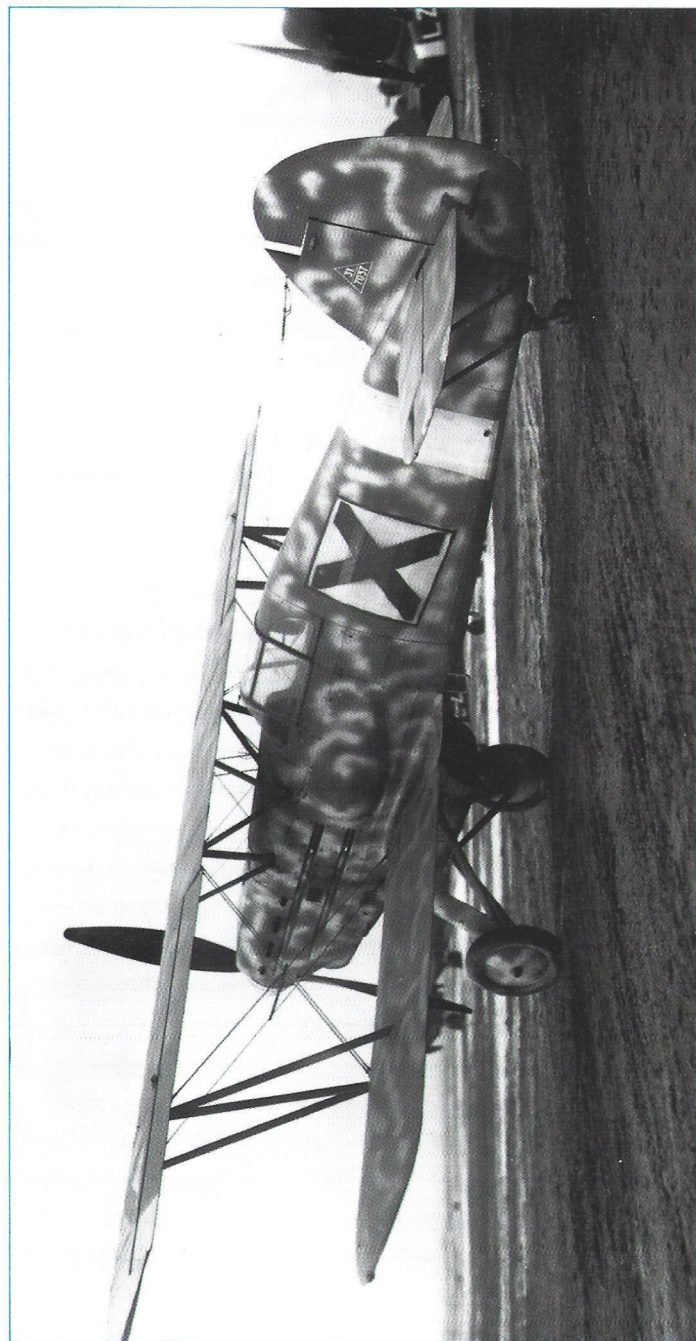
Superb two-third view of NN 31/7037, taken in late 1944, which allowed the artist to create an accurate artwork. The squiggle-style late war 'assault' camouflage scheme is prominent. There are two other shots of the same machine published on page 197.

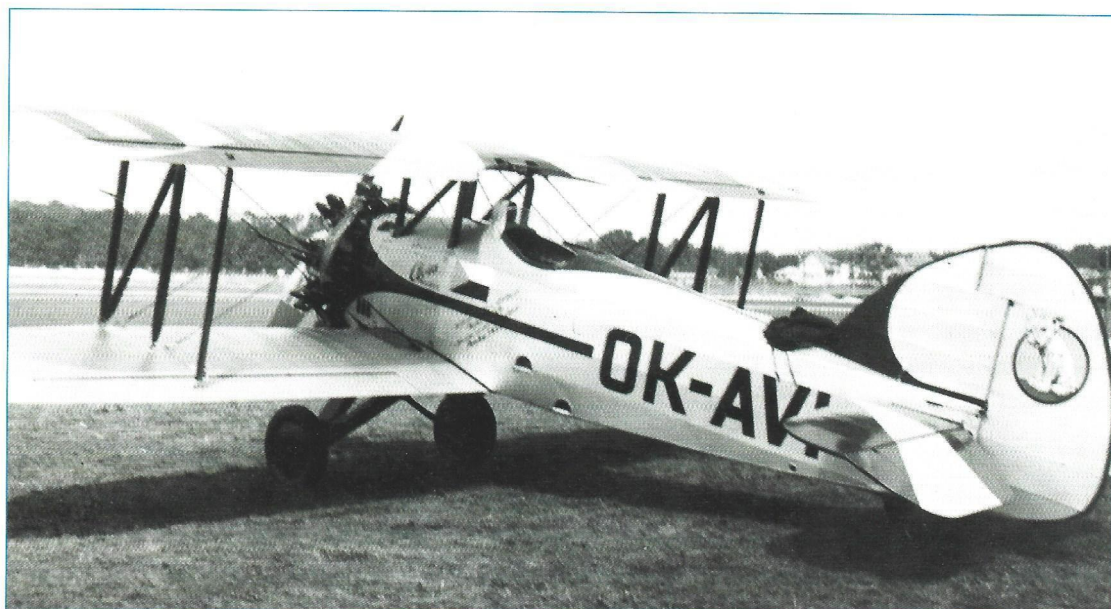
OK-AVI was the prototype of the Avia B.122 aerobatics biplane. The mixed construction airframe was powered by a seven-cylinder Castor II radial of 240 hp. It is depicted here at the international aerobatic competition called 'La coupe mondiale d'acrobatie aérienne', held at Paris in July 1934. The Bš.122 model was an evolution of this early prototype.

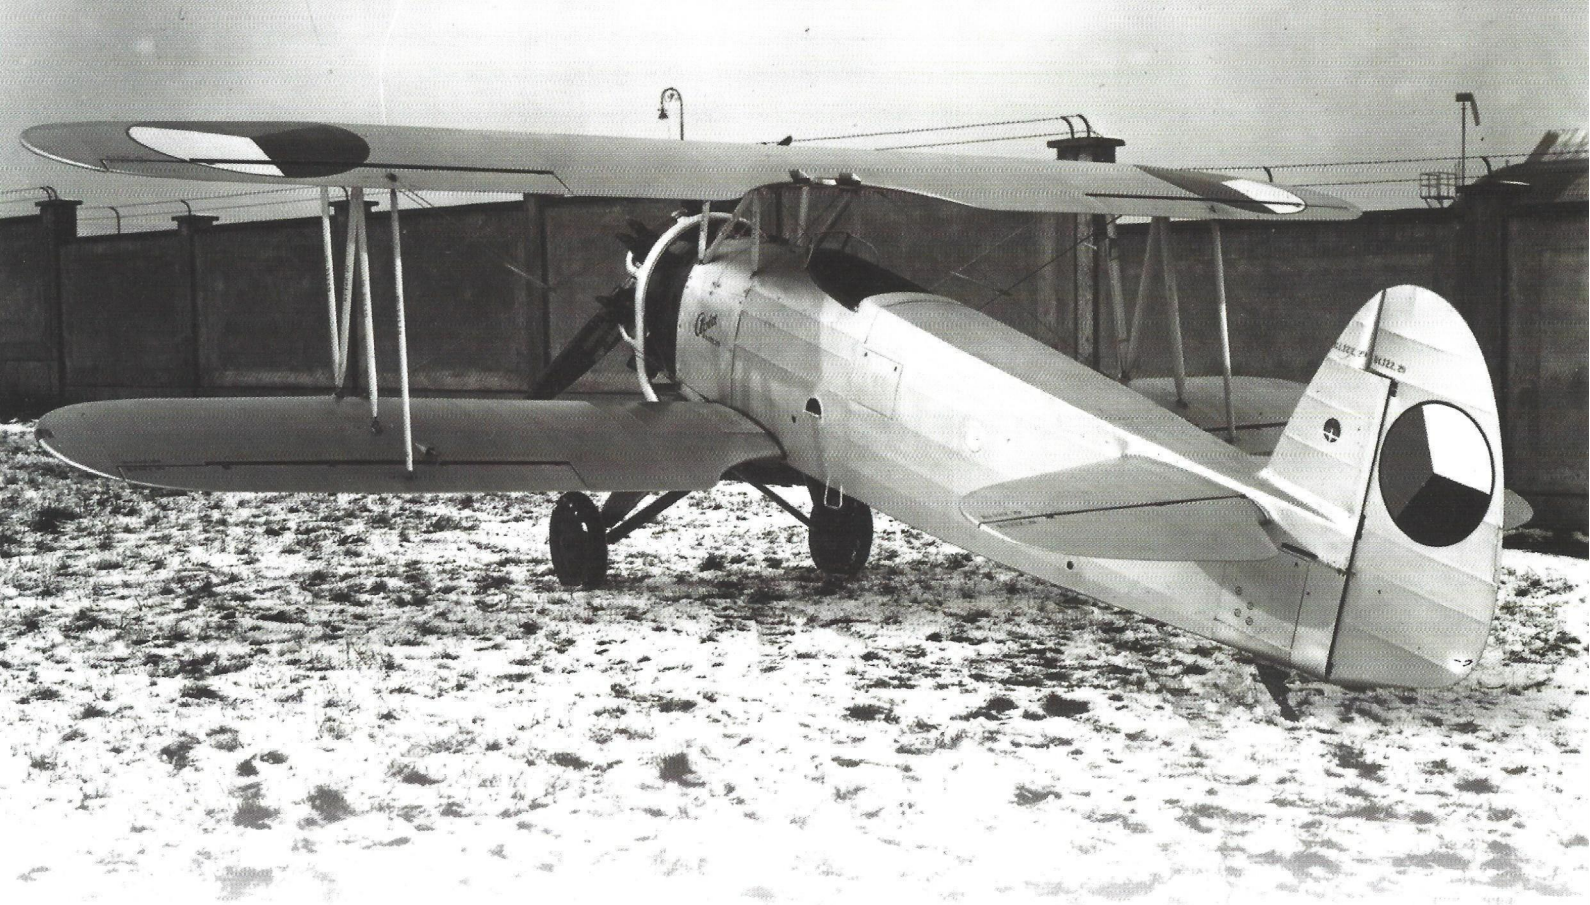
Superb factory photo of Avia
Bš.122.29 in its original
silver livery.

The Bš.122 was the improved military version of the single-seat advanced/aerobatics trainer type, the Ba.122⁶. The original B.122.1 prototype (OK-AVI) first flew on 12 May 1934, and the much improved Bš.122.1 on 11 August 1936, with factory test pilot Oldřich Košar at the controls. The airframe was of mixed construction. The iplane was powered by a seven-cylinder Walter 'Castor' IIA radial engine of 240 hp. In total, 45 Bš.122s were ordered by the Czechoslovak Ministry of National Defence from the Avia factory in 1936. All of them entered service with the Czechoslovak air force in the following year. The aircraft captured by German troops during the invasion of Czechoslovakia in March 1939 were impressed into *Luftwaffe* service, or placed in storage. Some were then sold to the Axis allies, Bulgaria and Slovakia.

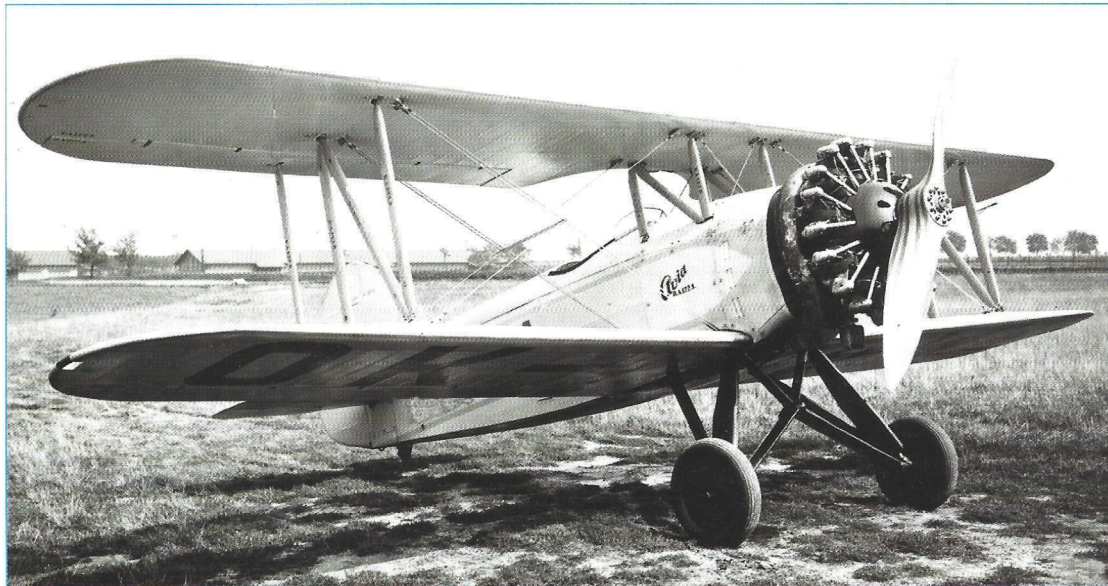
This photo depicting 'Avia B.A. 122.8' (see front fuselage side, wing struts, wingtips, as well as fin-and-rudder) comes from Bulgarian sources. It's unclear if it had any connection to the Bulgarian aviation, as the construction number of the single Ba.122 in Bulgarian service was 45. Curiously, the Czechoslovak register was retouched from the rear fuselage, but was left on the wing undersurface.

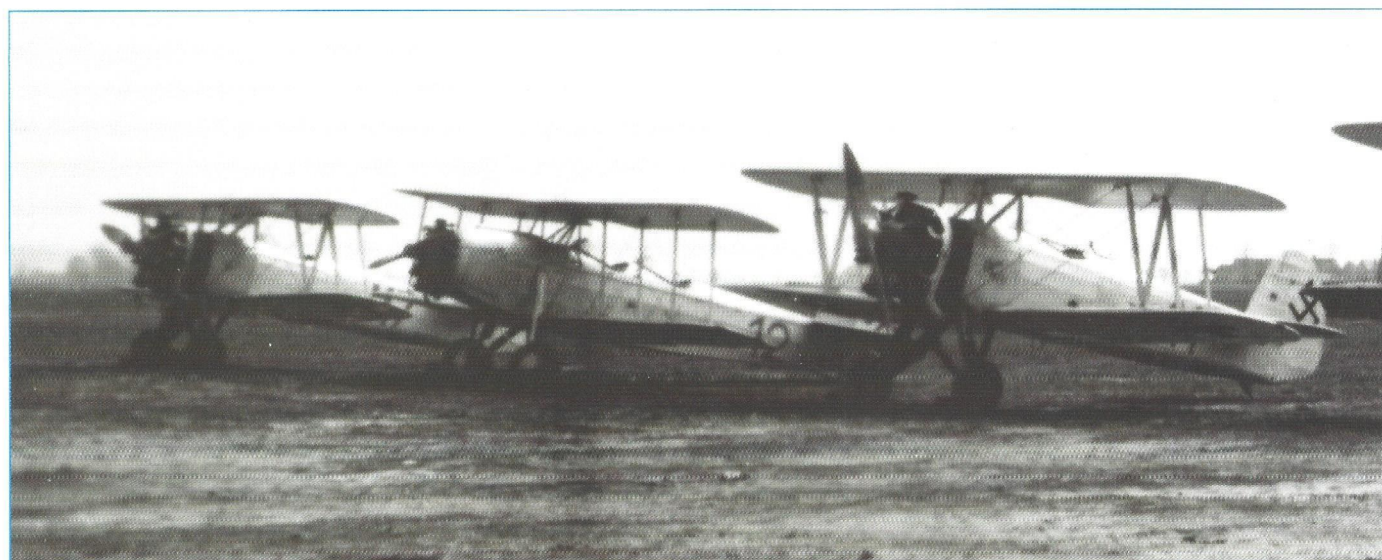
This Avia Bš.122 is shown shortly after the Germans seized control over the Avia Works in March 1939. The aircraft keeps its original Czechoslovak serial number 43C on the fuselage side, but already sports Luftwaffe markings. If the airframe's construction number, written under the slanted AVIA letters on the front fuselage, as well as on the wing struts, is 35, then this particular aircraft ended up in Bulgaria, as Osa No. 14.

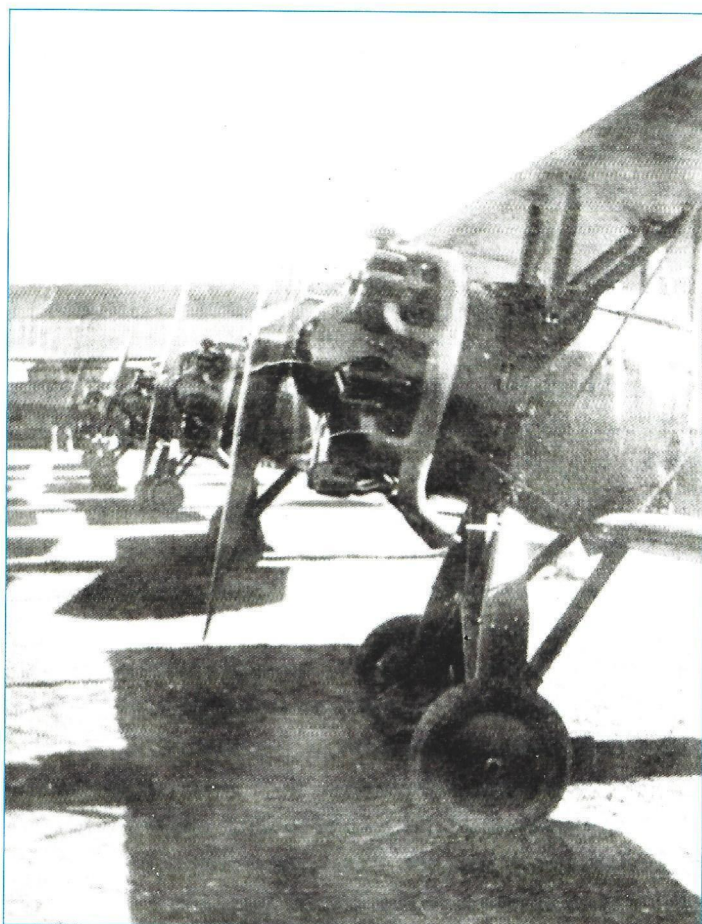
Possibly the same row of six Avia trainers depicted on the preceding page is shown at a steeper angle. The seven-cylinder Walter 'Castor' II radial engine of 260 hp is shown prominently. Some front engine covers (behind the propeller hub) displayed holes, others not.

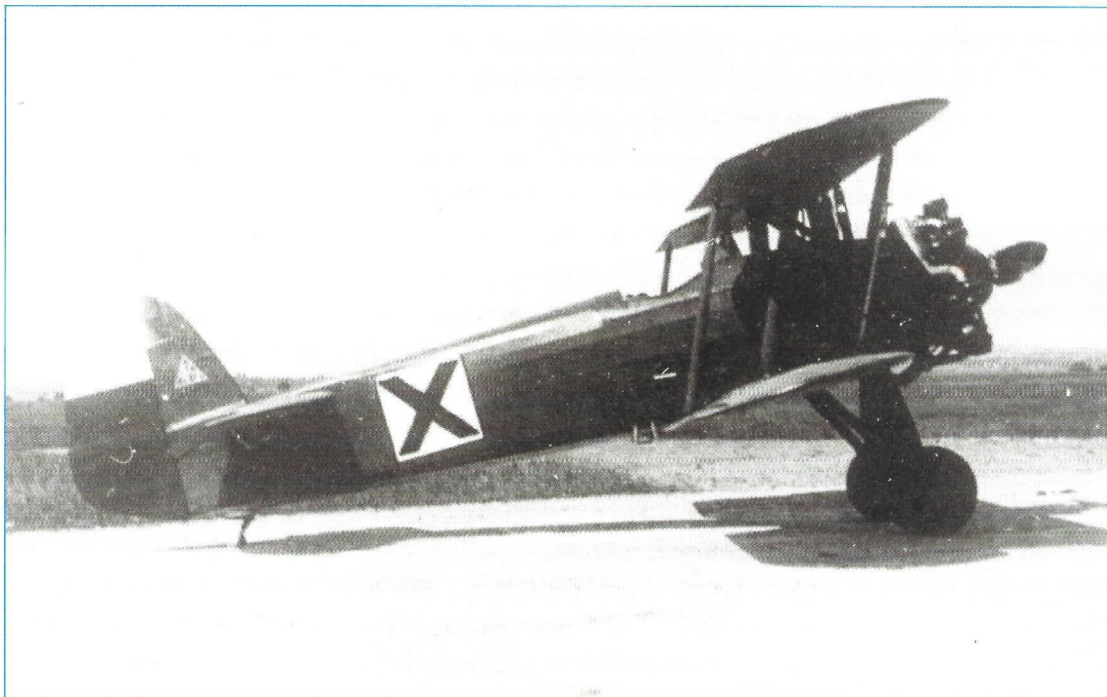
In late June 1940, a new military marking was introduced, in line with the other Axis powers' cross-shape markings. The depicted Avia Bš.122, No. 17, displays this new VNVV markings sometime in the late summer of 1940.

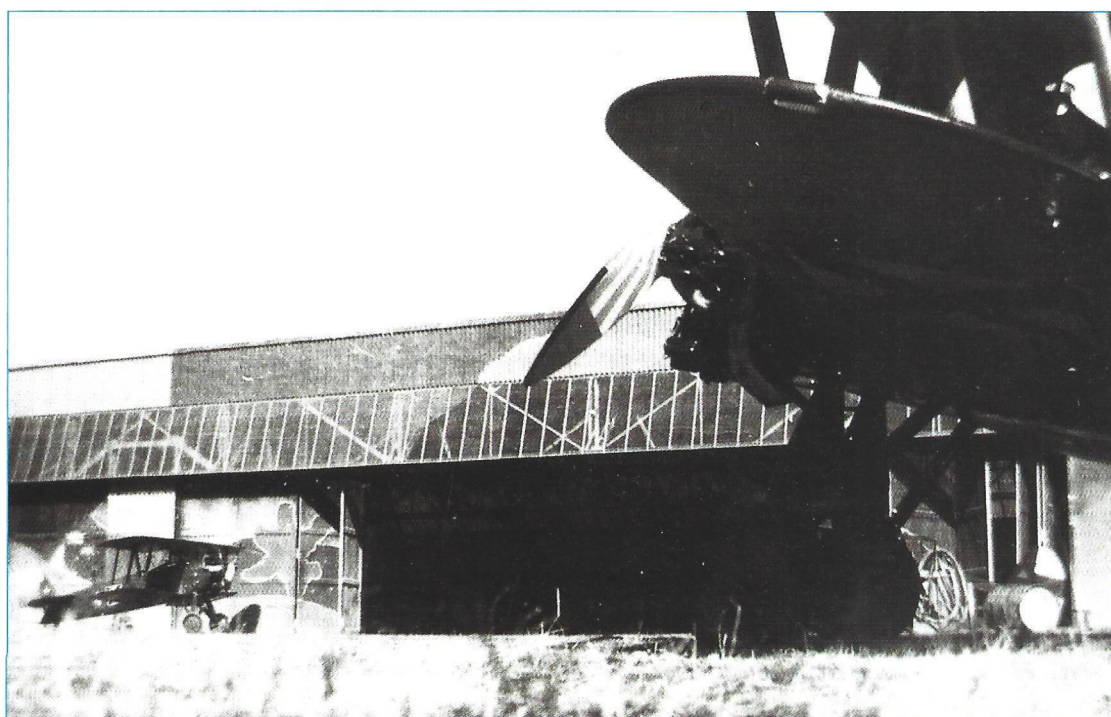
A trio of Avia fighter trainer biplanes is depicted on Bozhurishte main air base in the second half of 1940. The rudder is painted in Bulgaria's national colours. Oddly, the rudder is not divided equally in one-thirds for each colour, as is the case on other aircraft types, but the white (on top) and red (on bottom) stripes are wider than the green (in centre). The aircraft at right is No. 2.

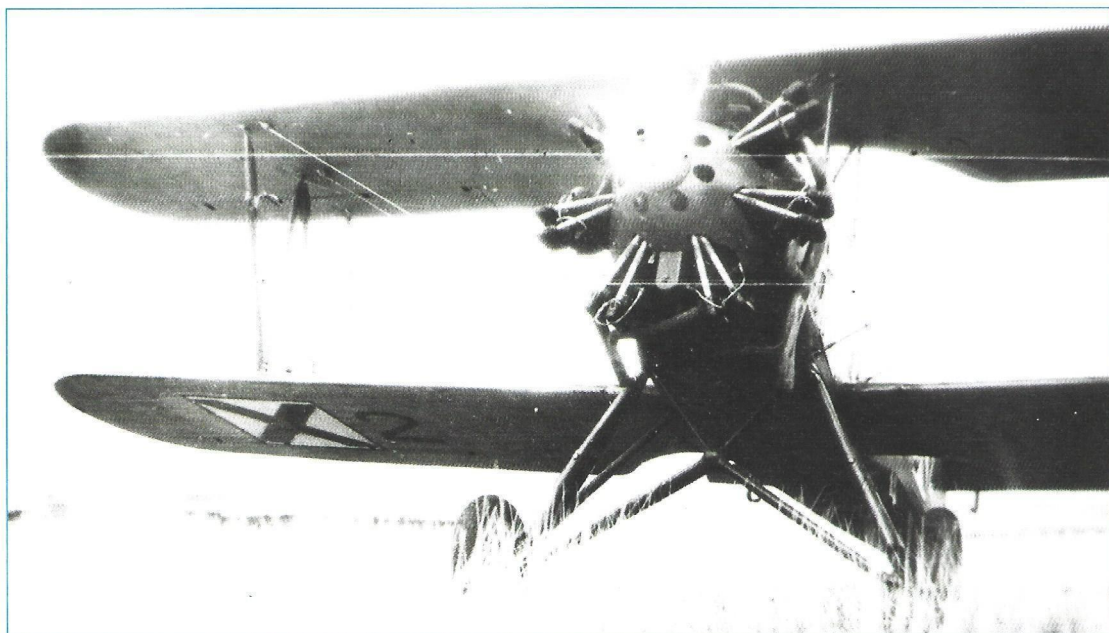
Aircraft No. 2 has its serial number applied on the lower wing surface – a rare occurrence. The egg-shaped cylinder cooling holes on the engine cover plate were not always present. The curved exhaust collector pipe was also not identical on all 28 Avia Bš.122s.

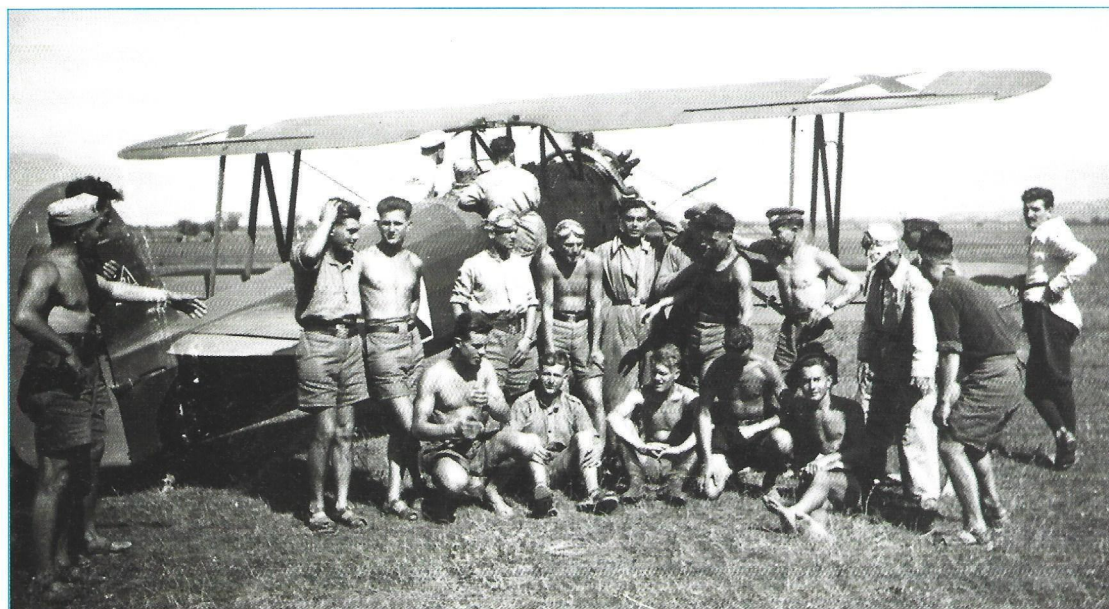
Pre-flight scene with student airmen and their instructor basking in the sun, near Avia Bš.122, No. 21. The rudder of the biplane is painted yellow, as are the elevators.

On this particular aircraft, No. 9, the cooling holes are missing from the round engine cover plate. The other photo taken at the same time reveals that No. 22, seen at left, also does not have holes in the spherical shape plate.

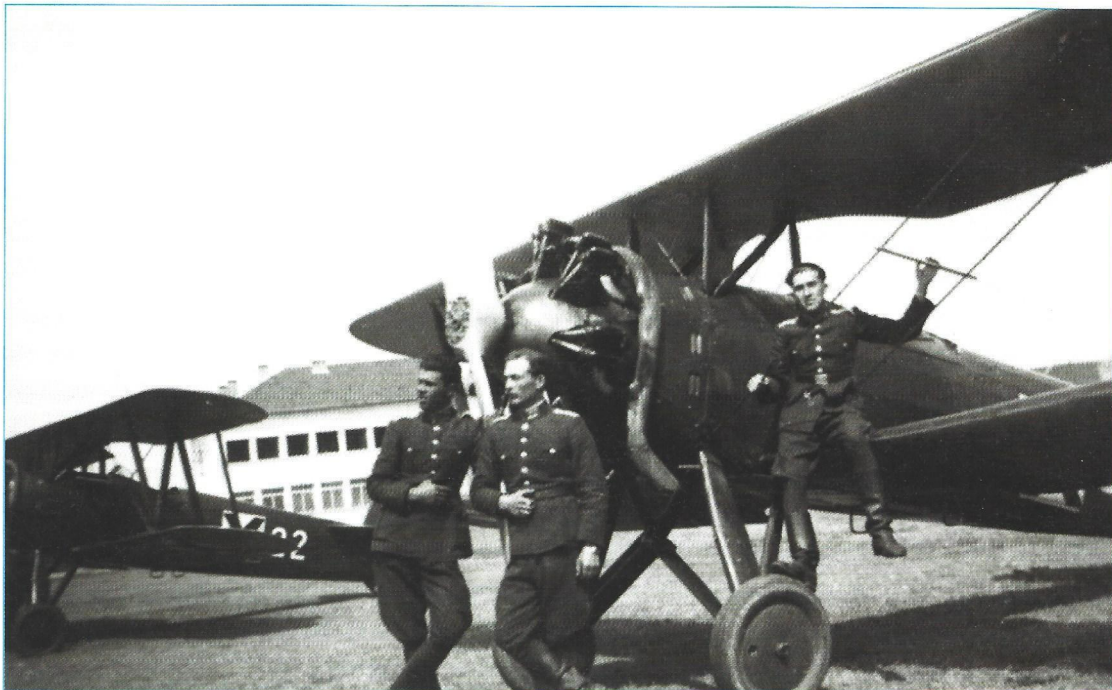
Another view of the same scene, revealing the serial number of the nearest Osa as being 9. Two Focke-Wulf Fw 56 Komars are visible in the background. Both types were classified by the VNVV as advanced fighter trainers, and accordingly had their four-digit Nomenklaturen Nomer (Register Number) ending in 3.

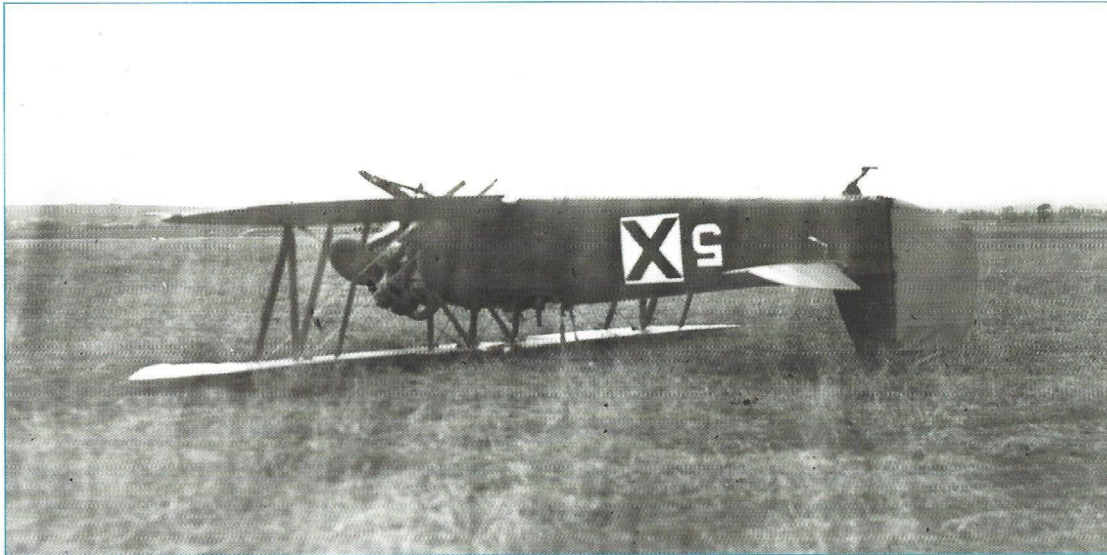
Osa No. 5, flown by Podporuchik Petăr Vladimirov Dimov of the 662nd Iztrebitelno Yato, 6th Polk, somersaulted while landing on Karlovo airfield on 27 April 1942. The aircraft was damaged 80%. The yellow rudder and elevators are visible. Notice the light colour painted engine front cover has cooling holes in it – one for each cylinder.

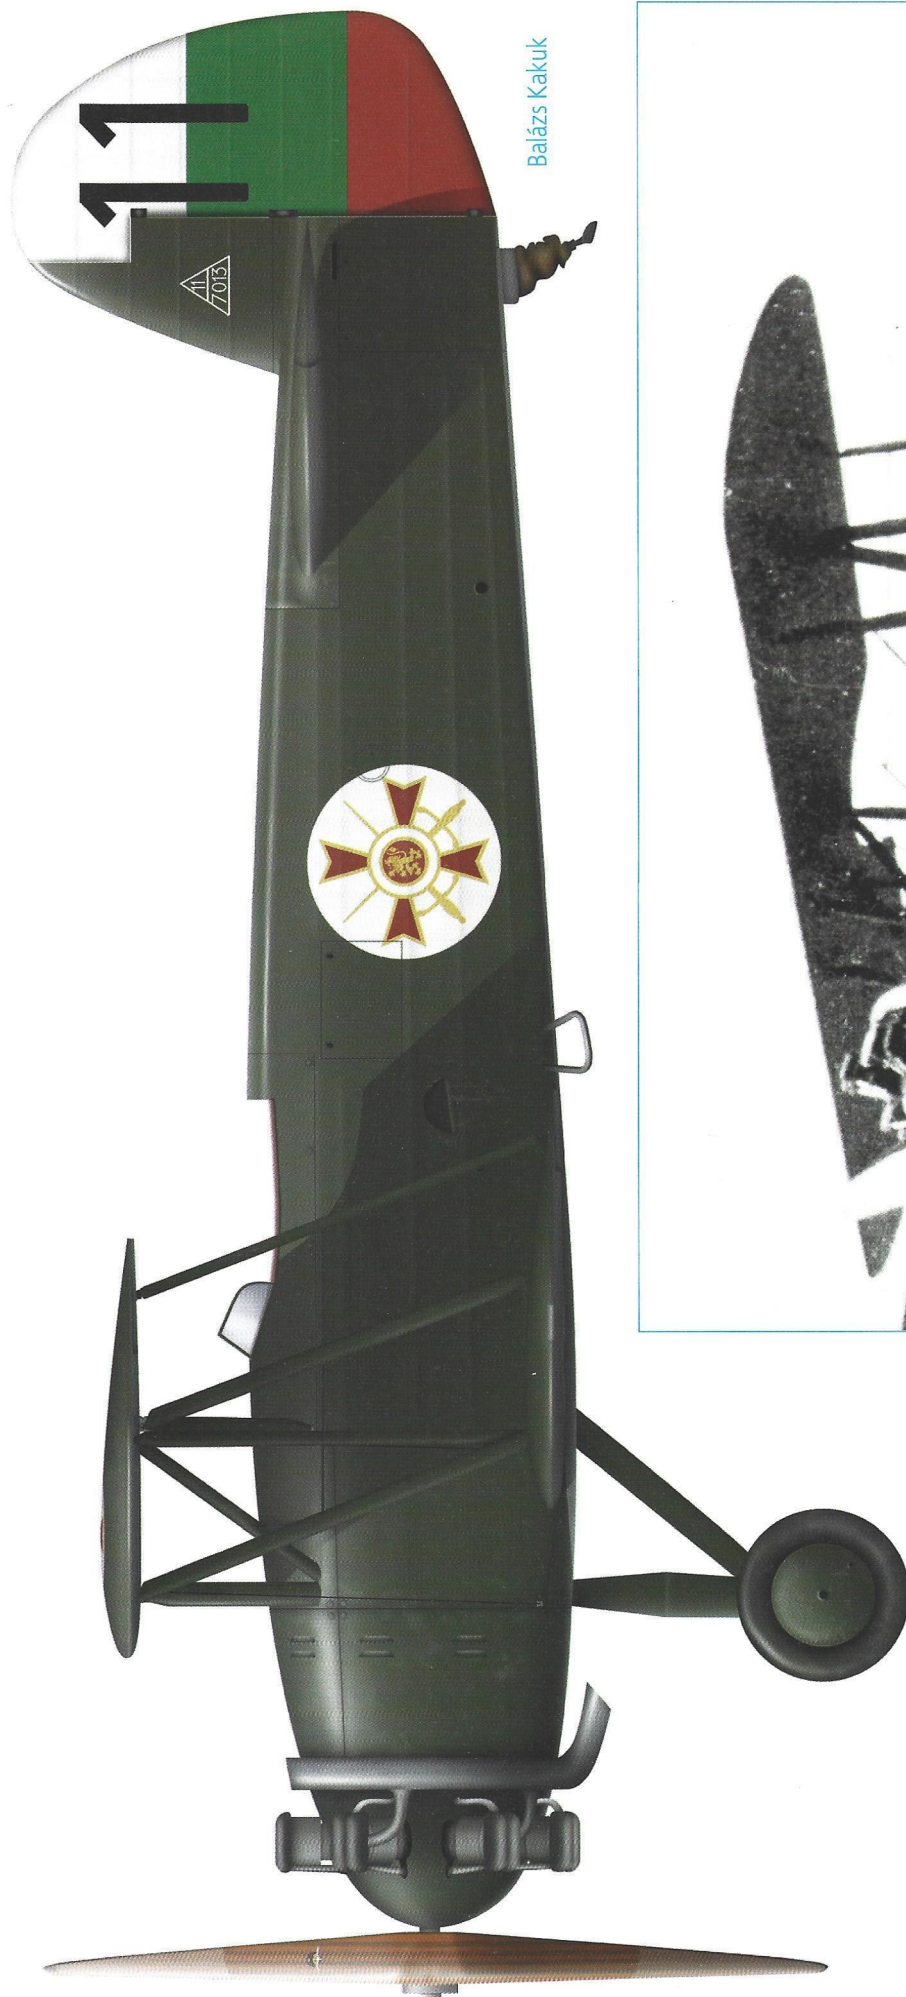
Avia Bš.122-22, 'Black 11', 11/7013, Shkola za Viss Pilotazh (High Aerobatics Piloting School), Marno Pole/Karlovo, May 1940. Camouflage colours: Dark Green upper surfaces, Light Blue under surfaces. Roundel-style national marking in six positions. Rudder in Bulgarian tricolour (White, Green, Red). Black serial number on rudder top.

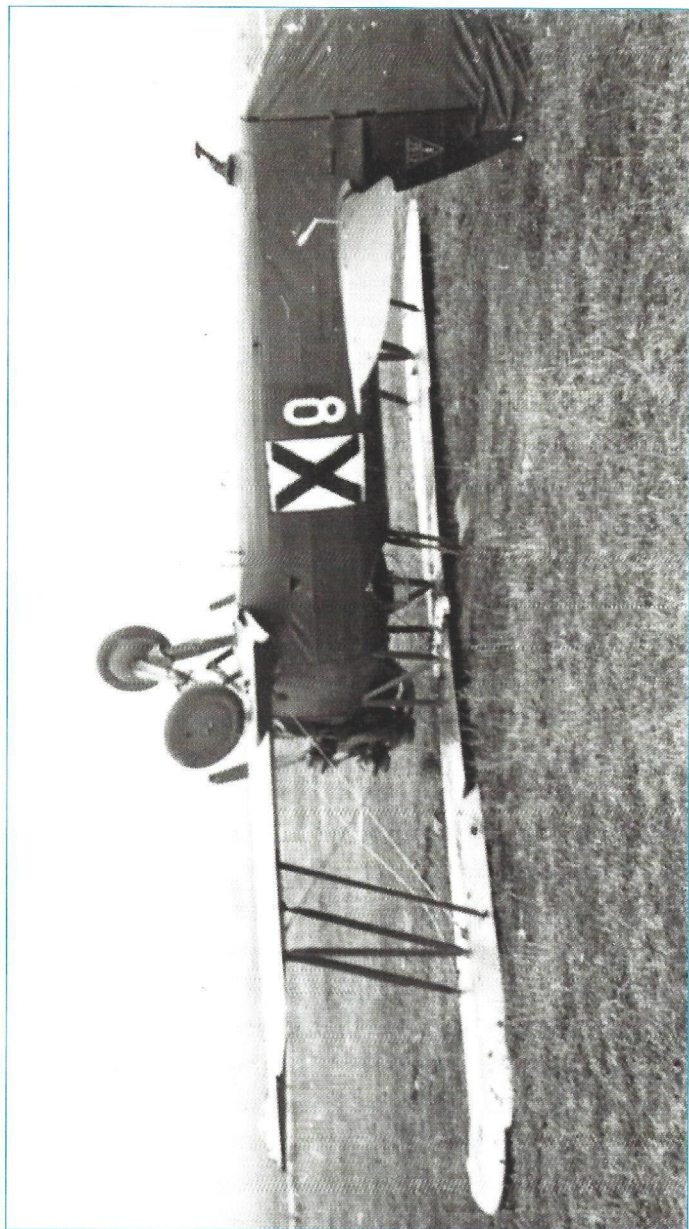
Avia Bš.122.14, 'White 8', 8/7013, 3/6. Iztřebiteln Orlyak, 692. Yato, Zamestnik ofitser (Warrant Officer) Gencho Dimitrov Ivanov, Marno Pole (Karlovo), 6 November 1943. Camouflage colours: Dark Green upper surfaces, Light Blue under surfaces. Cross-style national marking in six positions. Yellow rudder and elevators. White serial number on rear fuselage side and on lower wingtips, in black.

The final accident of 1943 happened on 6 November. After completing a training flight, Zamestnik ofitser (Warrant Officer) Gencho D. Ivanov of the 692nd Yato landed on a grazing cow and somersaulted, breaking the main undercarriage and propeller. Aircraft No. 8 was repaired and resumed duty within weeks.

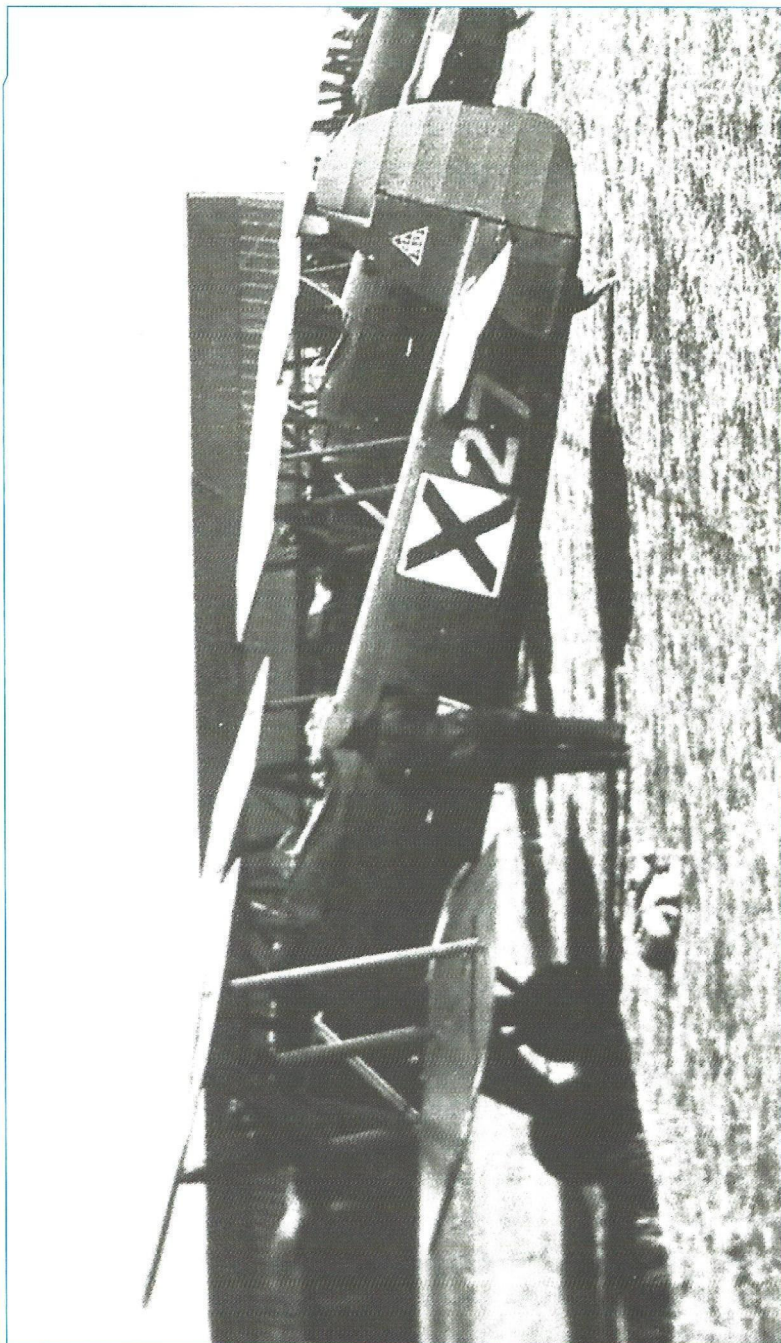
Avia Bš.122, 'White 27', 27/7013, Kazanlak, December 1941.
Camouflage colours: Dark Green upper surfaces, Light Blue under surfaces. Cross-style national marking in six positions. Yellow rudder and elevators. White serial number on rear fuselage side and on lower wingtips, in black.

'White 27' is parked in front of the hangars, on a grassy field covered by a thin layer of snow, in late 1941. Notice the yellow rudder (the elevators were yellow as well).
